RESERVE FUND STUDY

**BROOKVIEW COMMUNITY ASSOCIATION
EDMONTON, ALBERTA**

RE: Reserve Fund Study
Brookview Community Association
Edmonton, Alberta

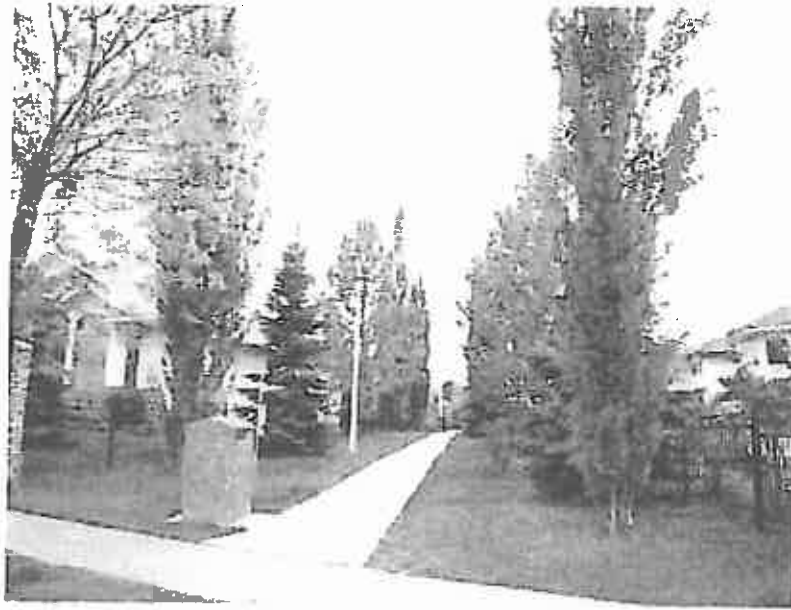
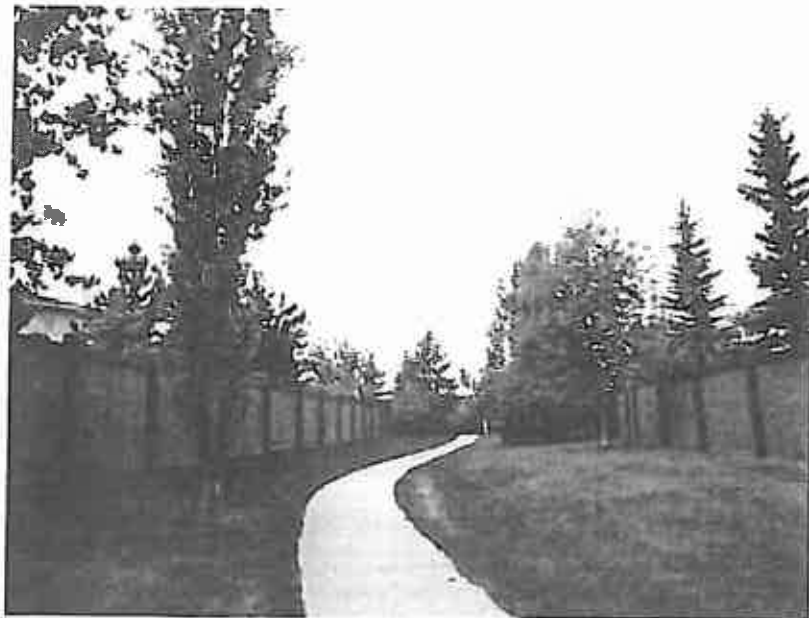
Exterior Views – Walkways

The three walkways are landscaped with a mixture of coniferous and deciduous trees. This reserve is a replacement provision.

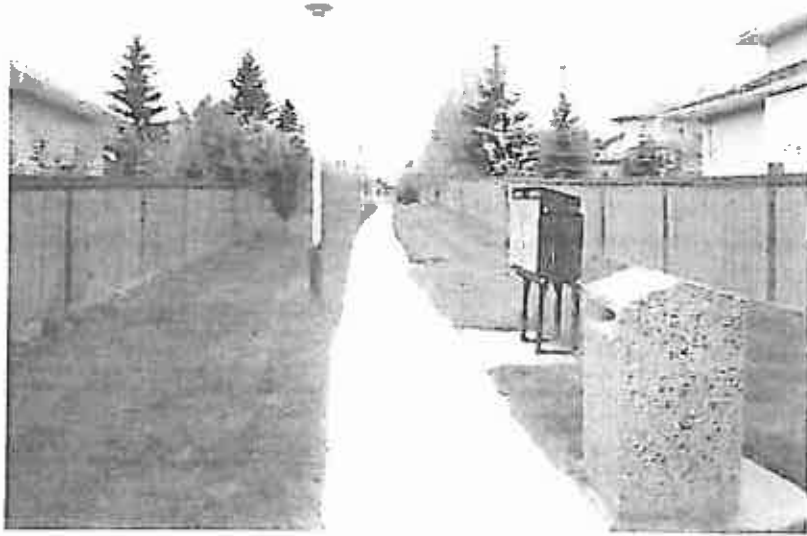
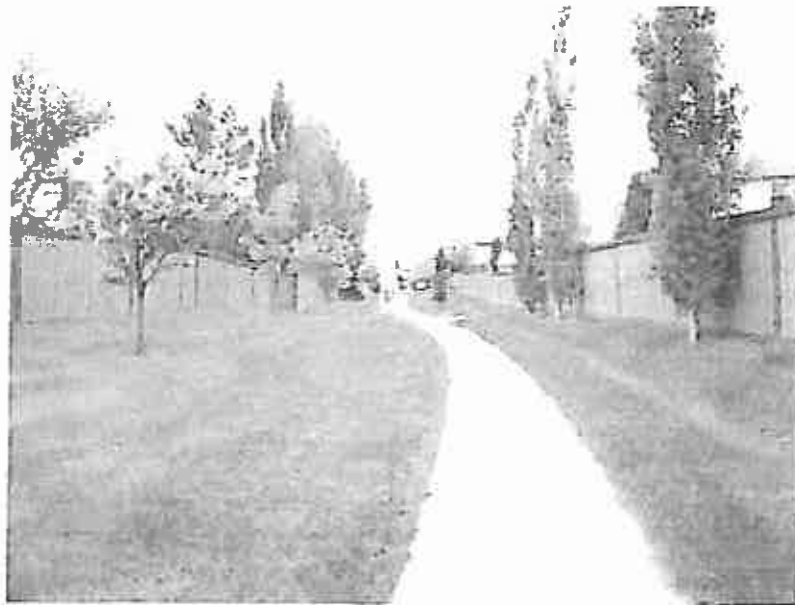
Exterior Views – Fencing

This is a long lived item which will require replacement is approximately 30 years. This reserve is a replacement provision. The fence consists of a 10 foot chain link perimeter enclosure with gates.

None noted.

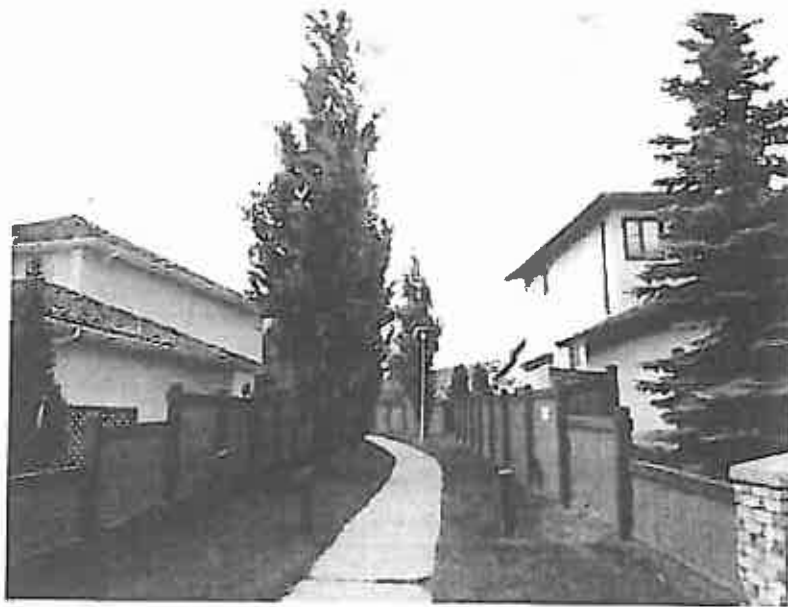
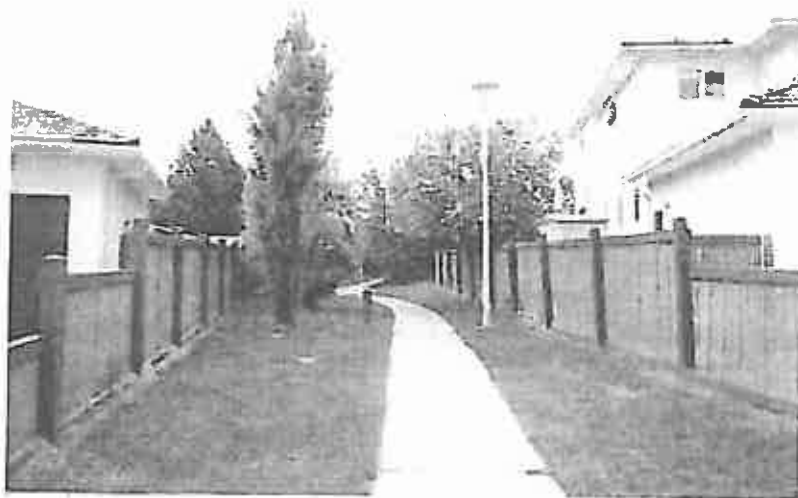
Exterior Views - Lighting

There are 34 walkway lights along the three walkway areas which are approximately 17 feet in height. This reserve is a replacement provision.

None noted. Poles appear to be maintained with no rust or significant deterioration.

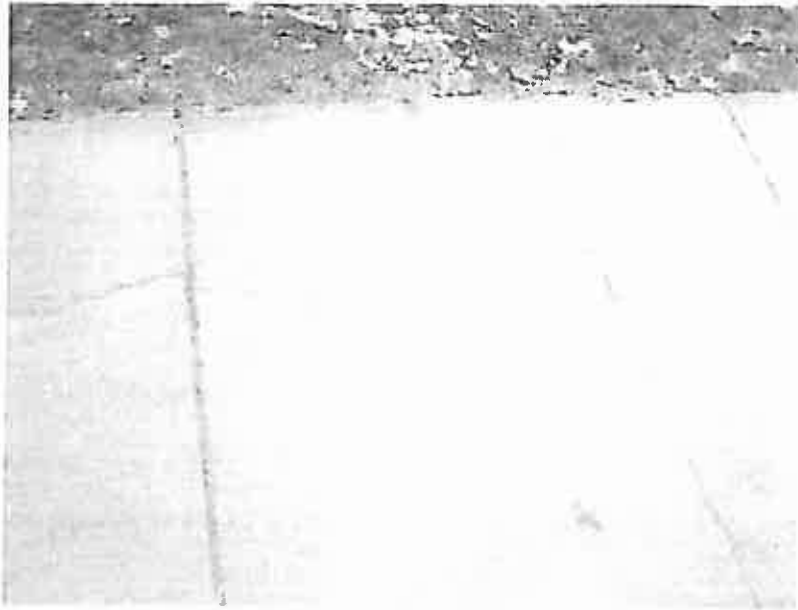
Exterior Views – Sidewalks

The overall effective age of the sidewalks is 10 years old and in average condition. The reserve allowance is essentially a replacement reserve which must be periodically reviewed as the sidewalks age.

Some areas are experiencing cracking and will need to be replaced in approximately 20 years with the majority in years 25 and 30.

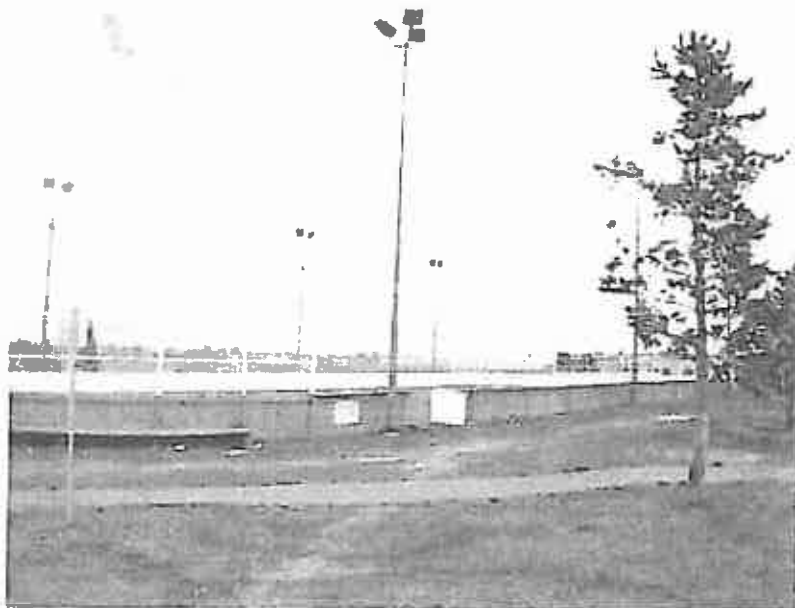
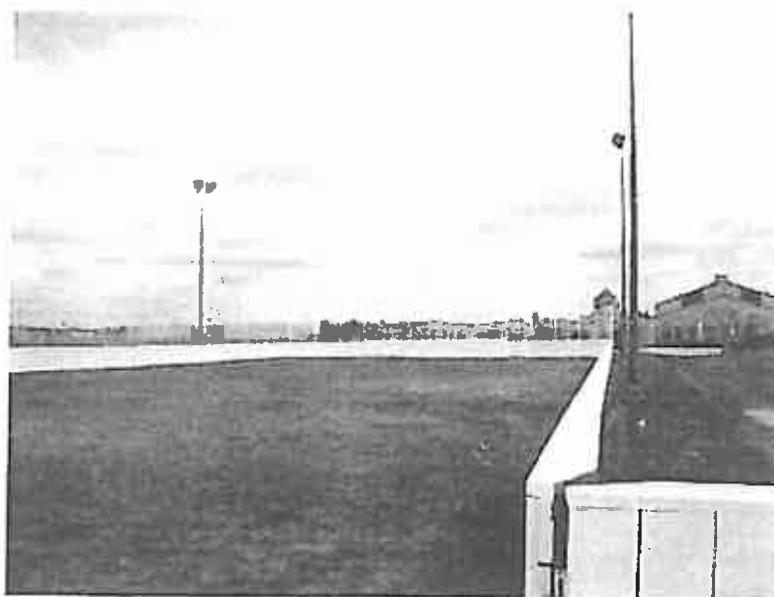
Exterior Views – Outdoor Rink

This reserve portion covers the hockey rink. It is approximately 84 feet x 184 feet. This reserve is a replacement provision of boards and flood lighting. It has been reported that the community association would be responsible for half of the total cost. The cost estimate below reflects the association's portion of the total cost.

The present rink is becoming somewhat obsolete in it's function for the community. Notwithstanding it's physical condition the community could anticipate replacement in approximately 10 years.

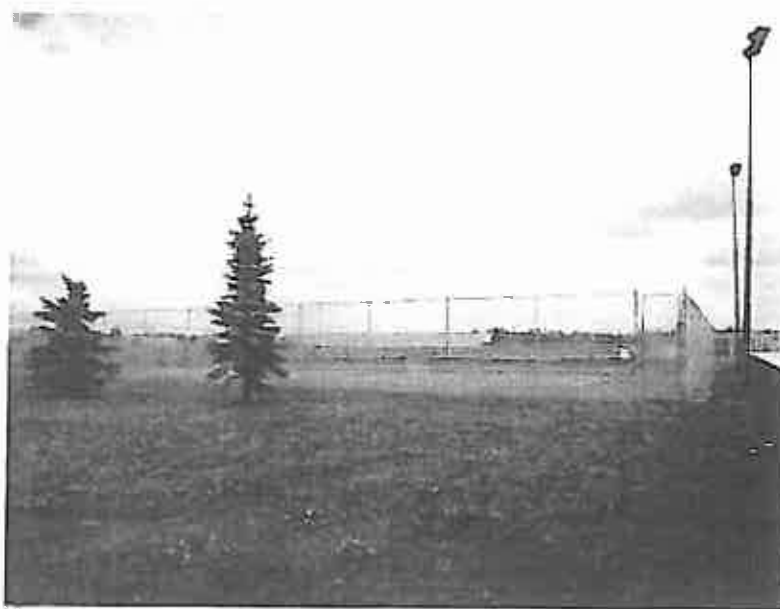
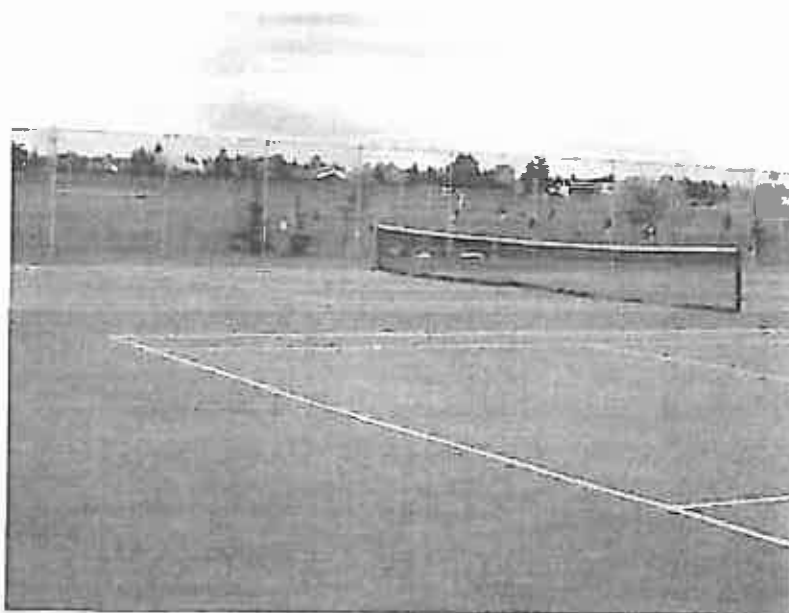
Exterior Views – Tennis Courts

The tennis court membrane is a rubberized membrane over asphalt surface. This reserve is a replacement provision.

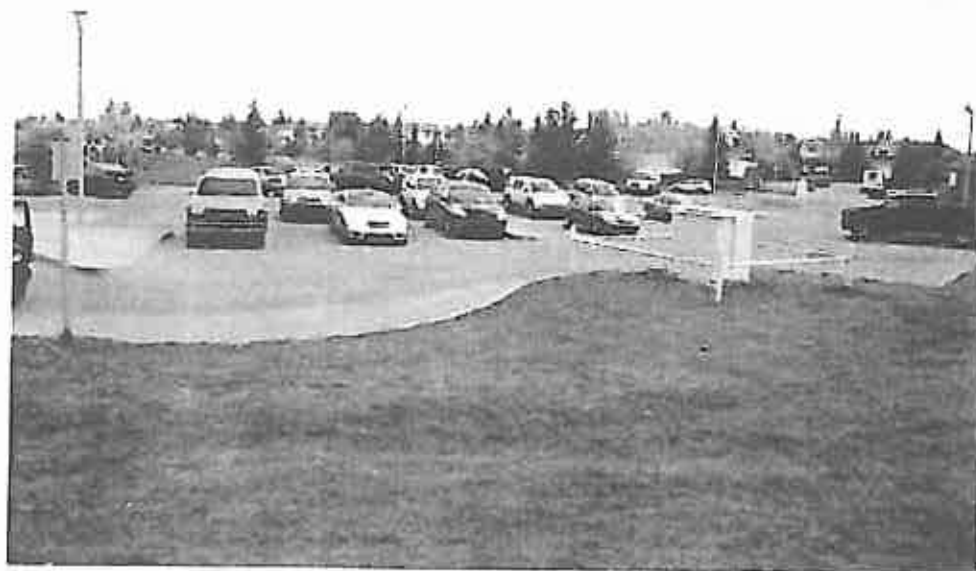
Exterior View – Parking Area

This reserve portion covers the asphalt parking area beside the playground, hockey rink, and tennis courts. The reserve includes repairs as well as replacement of asphalt paving.

None noted. The parking area is aging as expected but will require periodic maintenance for any cracks and potholes that develop.
